IP66 TEST REPORT

LED Tri-Proof Light

Model No.: FLT-TP-20L6, FLT-30L12, FLT-TP-40L12, FLT-TP-30L15,
FLT-TP-40L15, FLT-TP-50L15, FLT-TP-60L15

Report Number : ATT1706150177IP

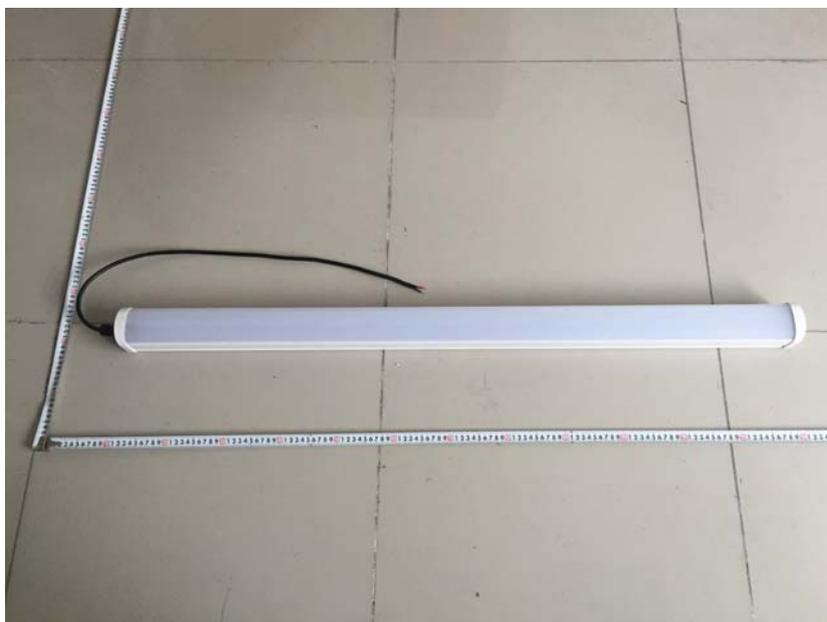
| Sample No. | Sample Name | Model/type | Quantity |
|---|---|---|---|
| 001 | LED Tri-Proof Light | FLT-TP-40L12 | 1pcs |

Sample Photo before the Test:

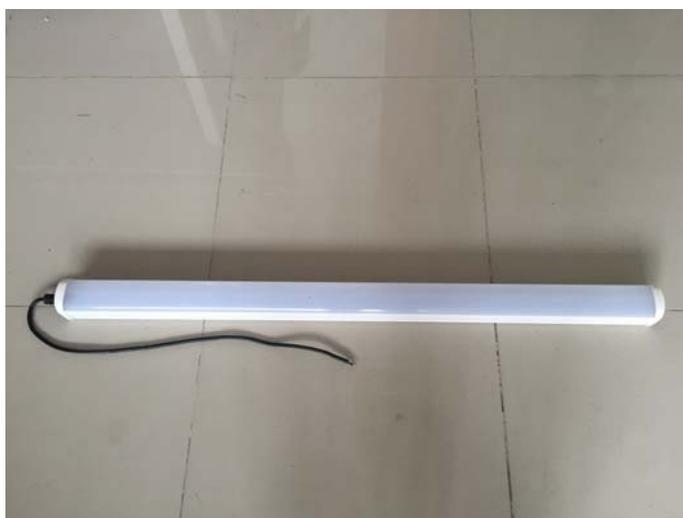
Test Result: The probe can't penetrate into any opening of the sample, there was no dust entered into the sample, sample passed the IP6X test.

Sample Photo after the Test :

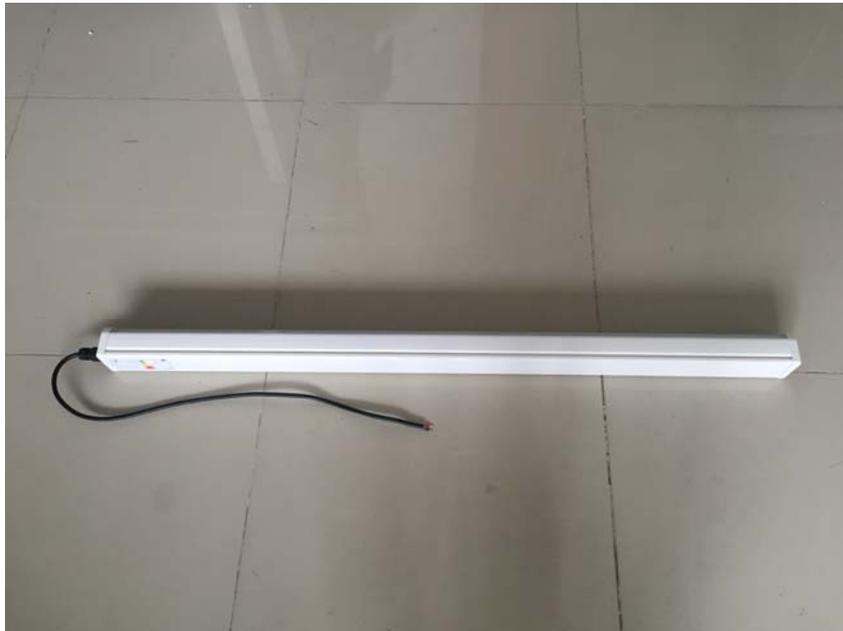
Test results: After the test, there was no water entered into the sample, sample passed the IPX6 test.
Sample Photo after the Test:
